IMPORTANT NOTICE

DATE	N.T.S.	BY	EHS	DATE	8/2/99	REVISION						NO.						TYPICAL					
DATE	N.T.S.	BY	EHS	DATE	8/2/99																								
REVISION																													
NO.																													
TYPICAL																													
EHS INC. ELECTRIC HEATING SYSTEMS ROBINNSVILLE, NJ																													
COLD TAIL WELD INFO:																													
SHEET NO. 1 OF 1 DRAWING NO. A-1013

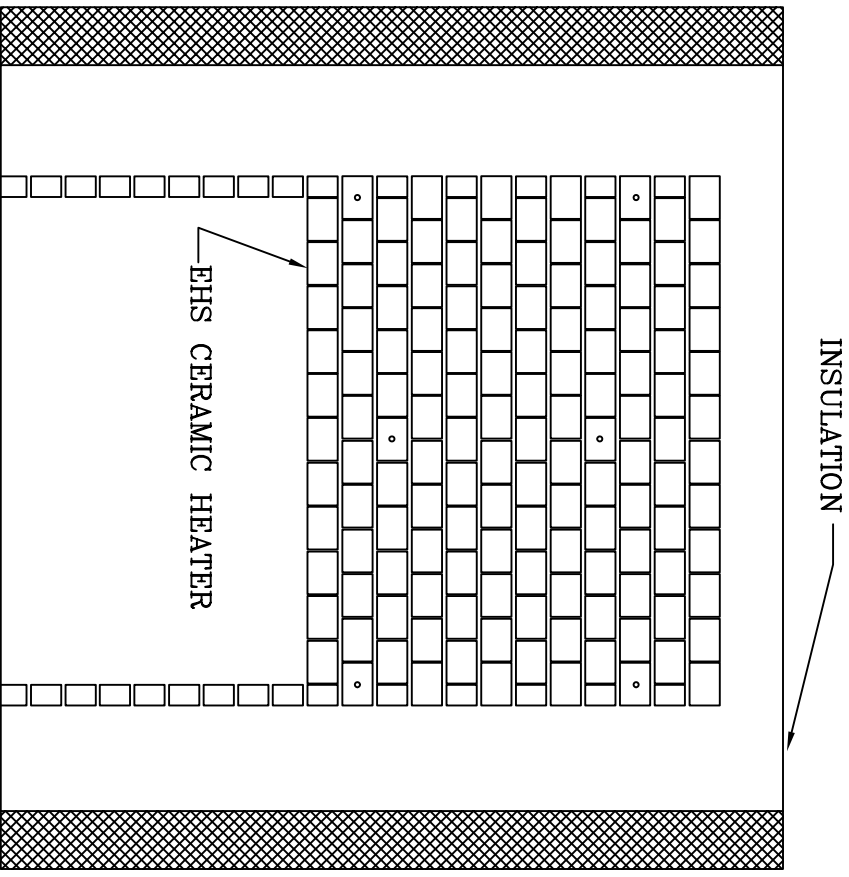
THE TAILS OF THIS HEATER ARE CONSTRUCTED BY WELDING NICKEL WIRE TO THE HEATER WIRE ELEMENT TO ALLOW FOR A COLD TAIL. THE CHANGE IN COLOR INDICATES WHERE THE WELD IS AND EXCESS HEAT COULD CAUSE THE NICKEL TO BECOME BRITTLE AND THIS MAY SHORTEN ITS LIFE.

TO INSURE A LONGER LIFE FOR YOUR CERAMIC PAD HEATER, DO NOT INSULATE PAST THE CHANGE IN COLOR ON THE TAIL BEADS OF THE HEATER.
